Water Resources of Wind Cave National Park

Natural Resource Report NPS/WICA/NRR—2016/1247

Marc J. Ohms

July 2016

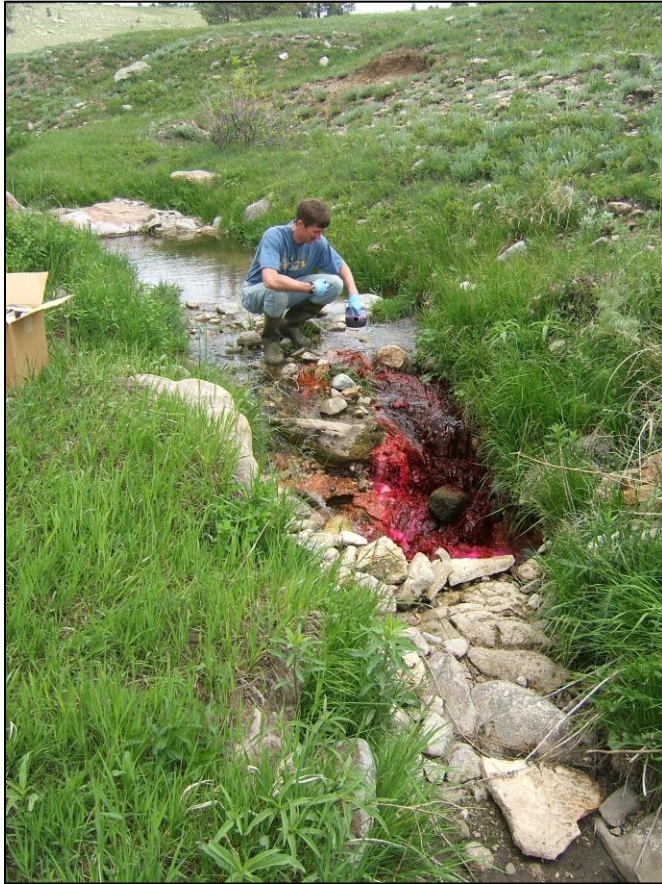
Photo 1. Injecting dye into Highland Creek (*NPS photo*)

several months. Eventually, the sink hole collapsed naturally and filled in. Currently, the stream again flows beyond the loss zone point. Dye was injected into the newly formed sink hole but the dye was not detected in Park Well #2 or in any of the lakes within Wind Cave (*Ohms 2012b*).

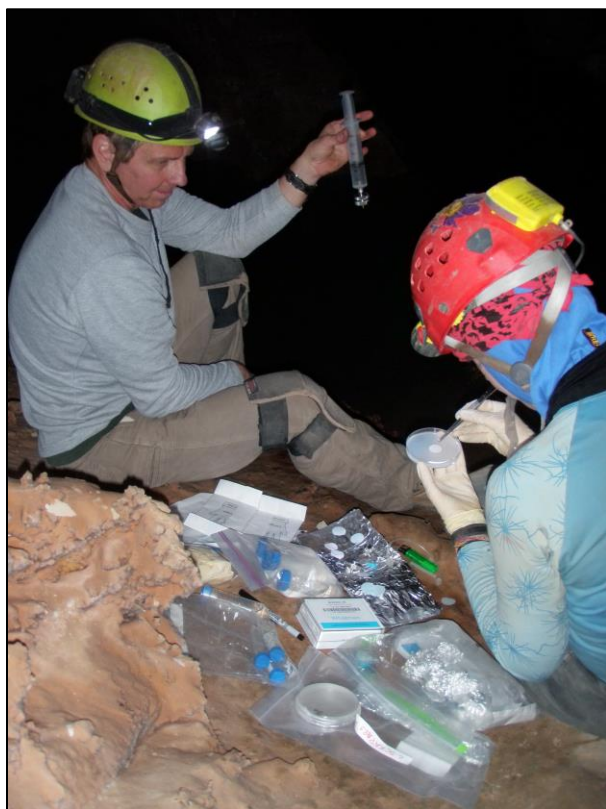
Photo 4. Microbiological sampling at Calcite Lake (*NPS photo*)

Barton (2011) sampled water from Calcite Lake to examine the micro fauna as a representative community of microorganisms living within this unique aquifer. In addition to sampling water within Wind Cave, Barton also examined microbial communities in other sites from the aquifer including Beaver Creek Spring, Park Well #2, and Streeter Well. These sites were both within and outside the boundaries of the Park. Barton's study represented the most comprehensive examination of a microbial community within a cave environment to date. The study found that the micro fauna of Calcite Lake represents a unique microbial community, with a highly diverse microbial community despite total cell numbers well below those previously observed in freshwater environments. The water in Calcite Lake has extremely low biomass, far below any encountered for any karst environment, aquifer or other studied body of water (*Barton 2011*).

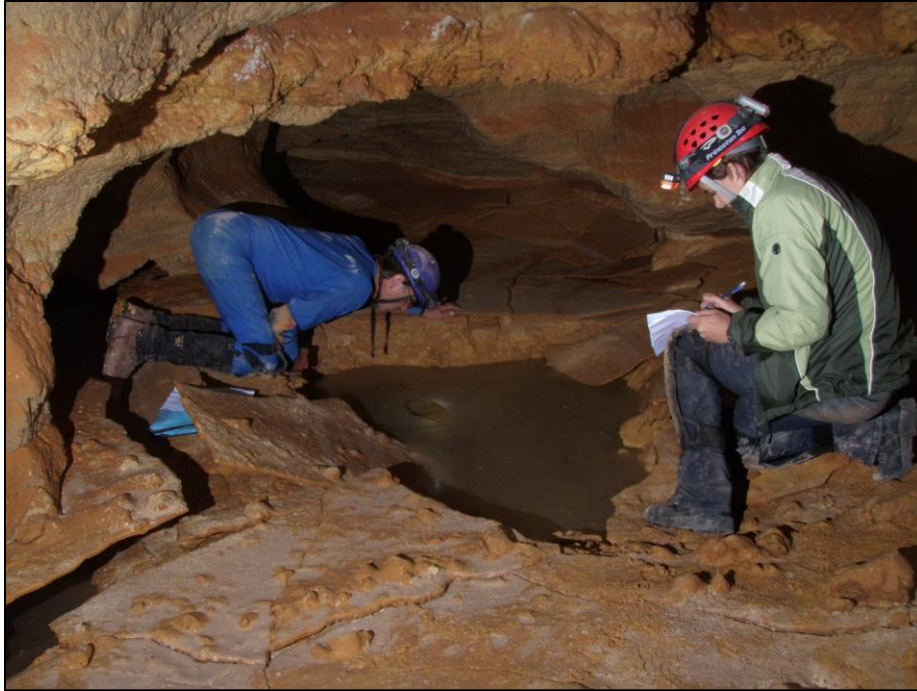
Photo 5. Searching for macro-invertebrates in Wind Cave (*NPS photo*)

Zara Environmental conducted a survey for groundwater macro-invertebrate fauna in and around the park. Lakes within Wind Cave were the focus of the study, but wells and springs in the surrounding area also were sampled for comparison. Visual searches, plankton nets, drift nets and baited traps at

19 different sites were used in an effort to capture fauna. No groundwater macro-invertebrate fauna were detected at any of the sites (*Zara Environmental, 2009*).

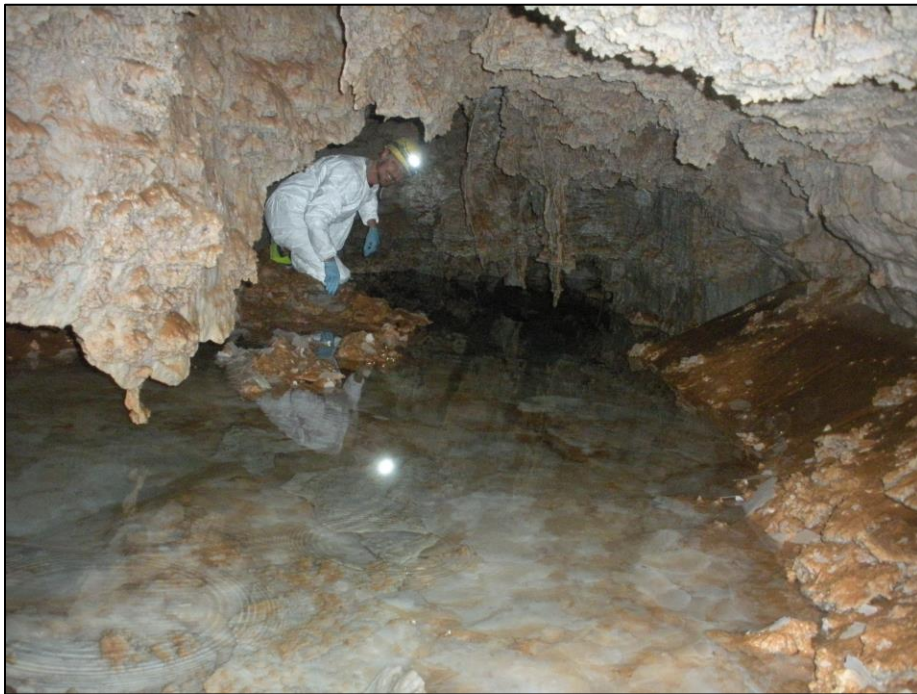
Photo 6. Deep End Lake (*NPS photo*)

In 2009, a series of pools (Deep End Lake) were discovered at the southwestern most point of the cave. It was believed to be the water table but due to the remoteness of the site, no sampling or research has yet been conducted.

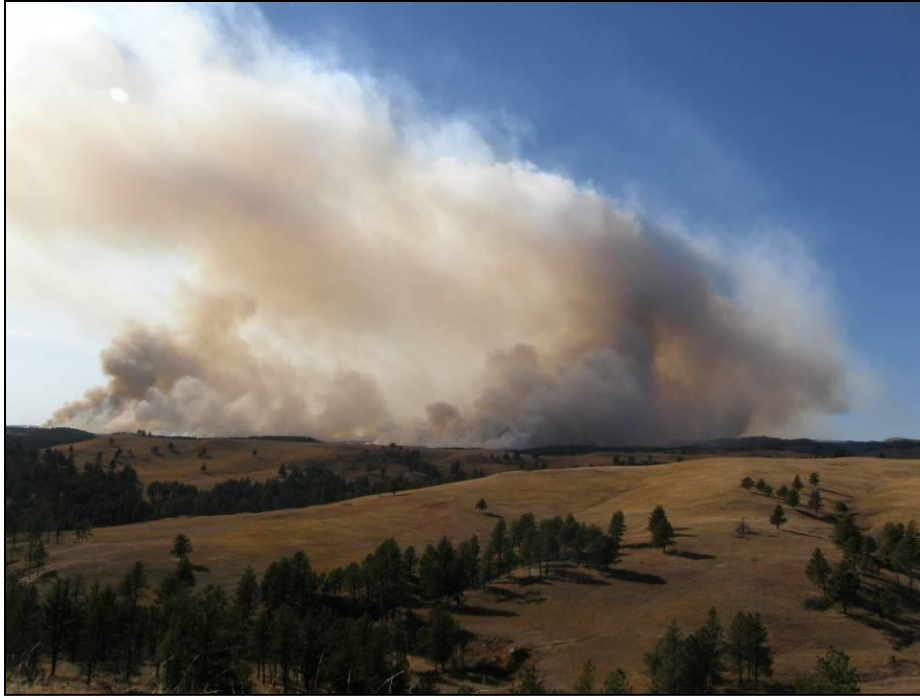
Photo 7. Bringing fire back into the ecosystem thru prescribed burning (*NPS photo*)

A lack of wildfire can influence the amount of regional infiltration and transpiration by allowing Ponderosa Pine to increase in density and to excessively encroach upon the prairie areas. In the past, fires were viewed negatively and suppressed. However, recently the necessity of fire to manage lands has become better understood. Over the past twenty years, the park has maintained an active prescribed fire program, helping to restore the role of wildfire in the ecosystem. A goal of the Park's prescribed fire program is to manage local water resources by controlling vegetation.

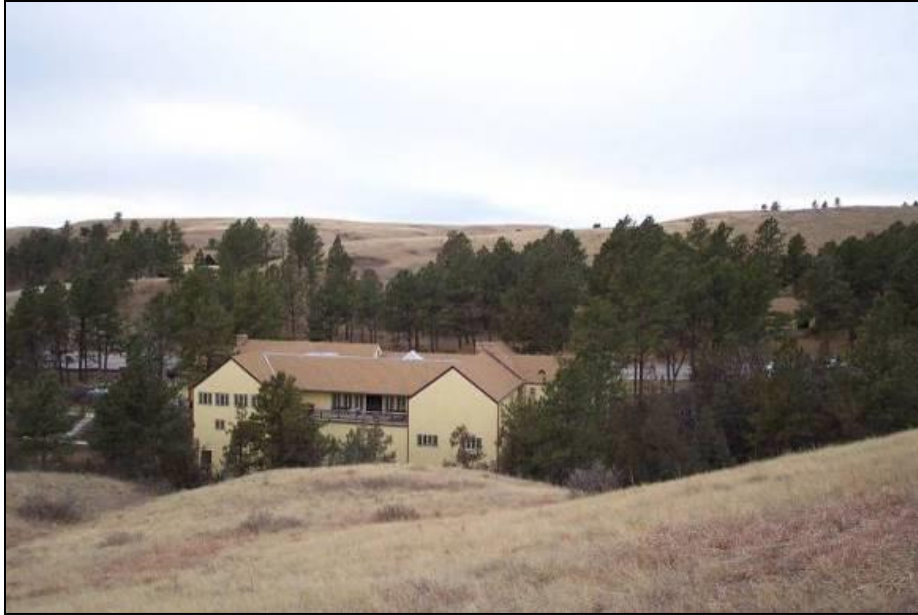
Photo 9. Visitor Center area in 2005 (*NPS photo*)

In 1935 the Civilian Conservation Corps (CCC) planted 5,000 trees and shrubs in the Park's Visitor Center area. Photographs taken during that time were compared to recent photos (below) to determine the effects of the vegetation on local watersheds. Recent photographs showed denser forests with increases in Ponderosa Pine growth (*Pace-Graczyk and Ohms 2006*). As seen in the pictures below, the CCC's efforts greatly increased the amount of vegetation in the area, which in turn decreased water volumes entering the cave network. This section of the canyon consists of a small outcropping of the Madison Limestone, which allow water to readily infiltrate into the subsurface aquifers. In 2011, the park began a project to remove non-native trees and excess native trees within the Wind Cave Canyon area around the Visitor Center.

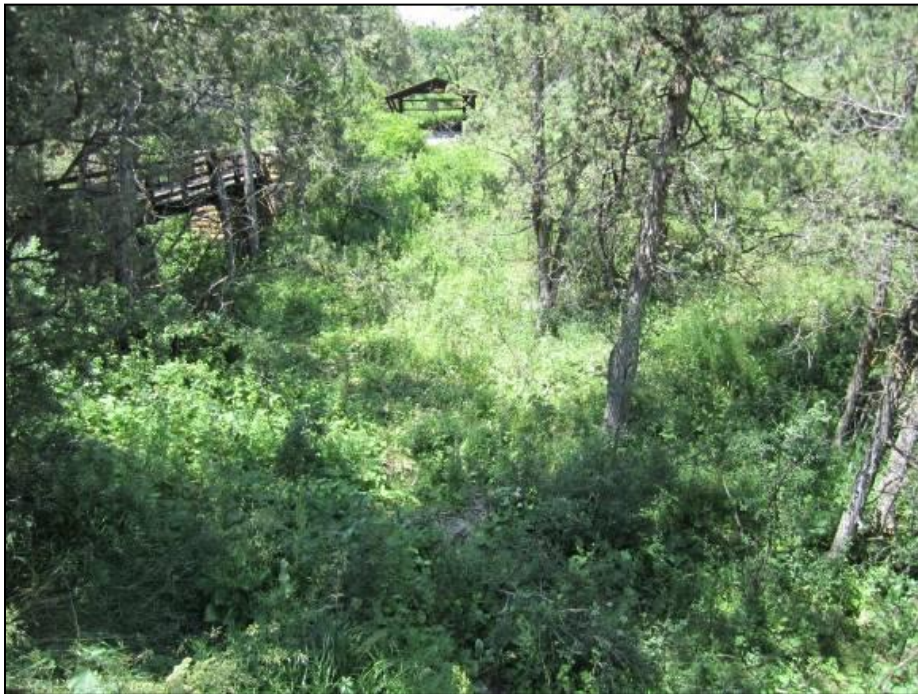
Photo 10. Wind Cave Canyon before thinning (*NPS photo*)

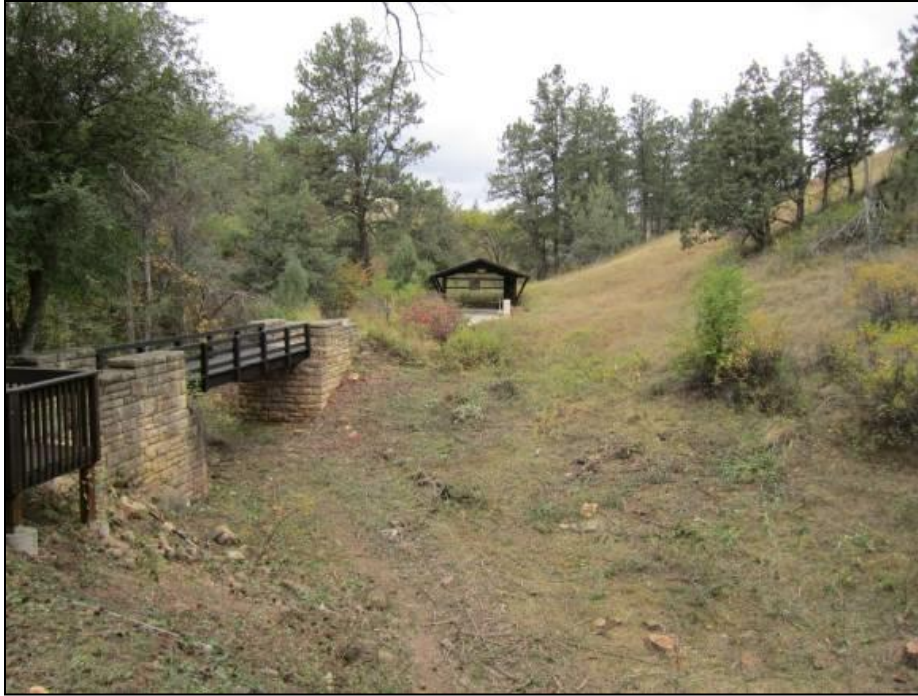
Photo 11. Wind Cave Canyon after thinning (*NPS photo*)
